Manhole Inspection Summary

Manhole # S25GG_052MH

Insp Date: **10/19/07 9:07 AM**

Location Address: **549 BLOOM ST**

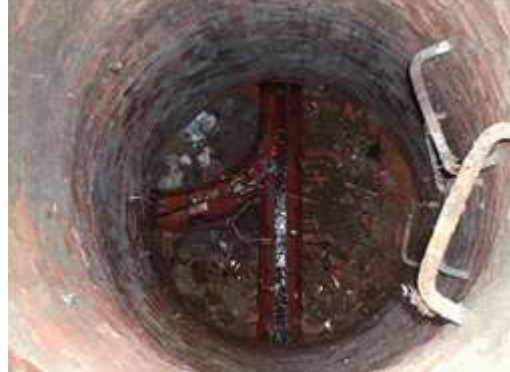
Top View

Evidence of surcharge - Bench debris.

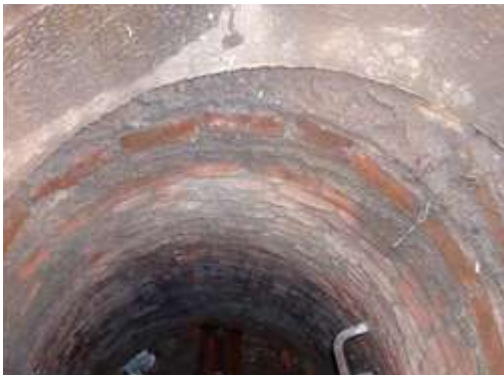
Defect

Frame leaks. Frame offset. Adjustment deterioration and infiltration. Corbel and Barrel infiltration - other side.

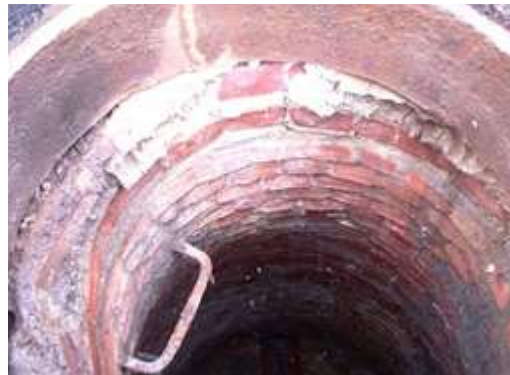
Defect

Frame leaks. Frame offset. Adjustment deterioration and infiltration. Corbel and Barrel infiltration.

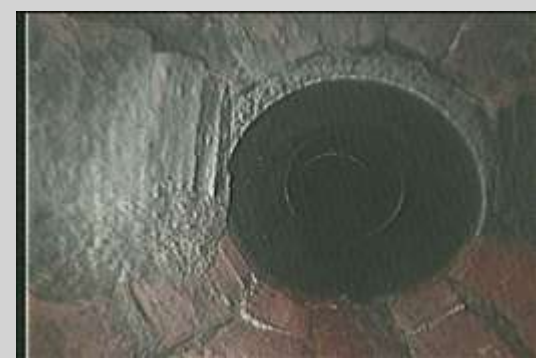
8 in. Circular Gravity Sewer Pipe Out @ 12 O'Clock

Invert Depth: **10.03** (ft.) Flow Characteristics: **Slow**

Infiltration: **Evidence** Pipe Seal Cond: **Cracked**

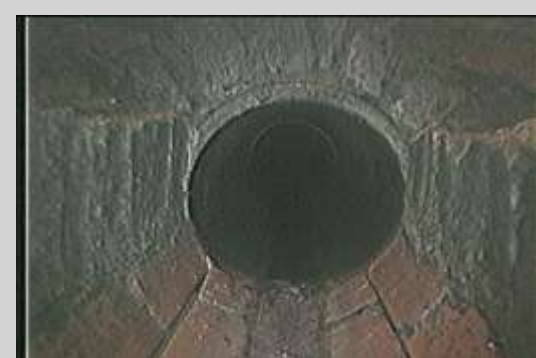
8 in. Circular Gravity Sewer Pipe In @ 6 O'Clock

Infiltration: **None** Pipe Seal Cond: **Cracked**

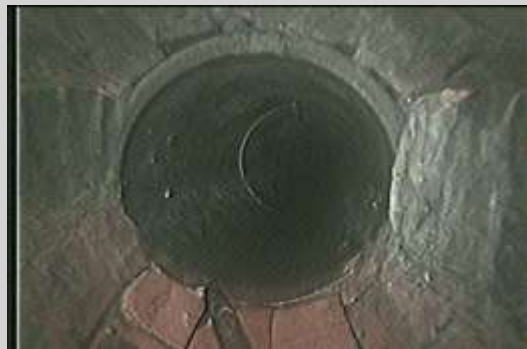
Pipe In @ 9 O'Clock

Infiltration: **Evidence**

Pipe Seal Cond: **Cracked**
